**COMPLIANCE CRASH TESTING OF THE TYPE 60K  
CONCRETE BARRIER USED IN SEMI-PERMANENT  
INSTALLATIONS**

FINAL REPORT # FHWA/CA/TL-2001/08  
CALTRANS STUDY # 680841

August, 2001

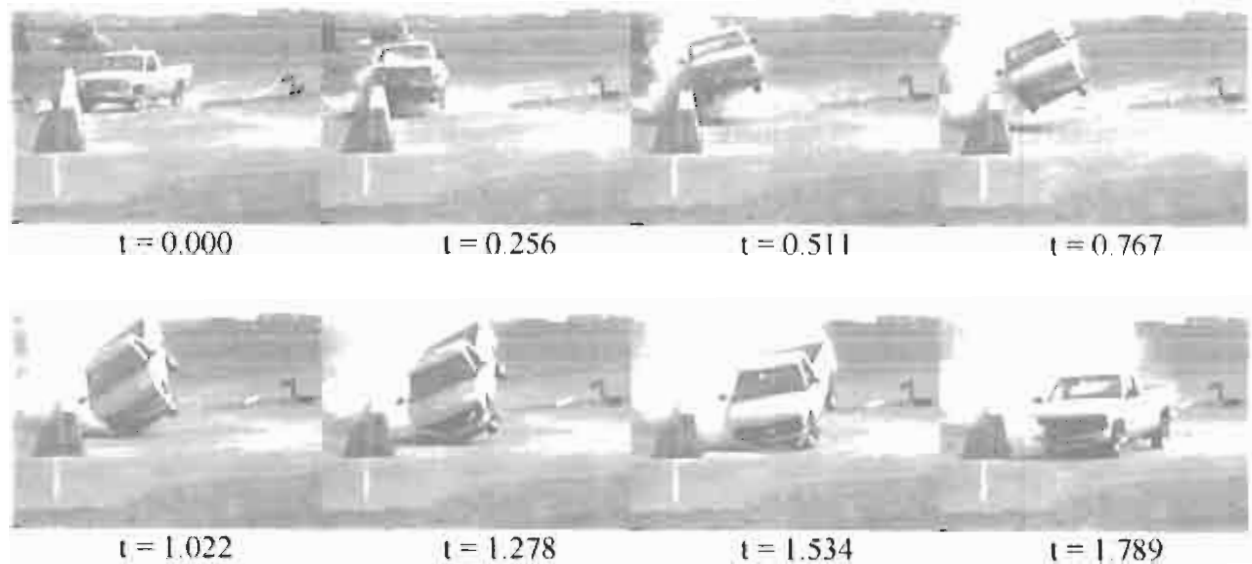
Figure 2-5 - Test 562 Data Summary Sheet

Barrier Damage: ..... There was no damage  
 to the concrete trough. Several of the  
 segments spalled along the bottom edges.

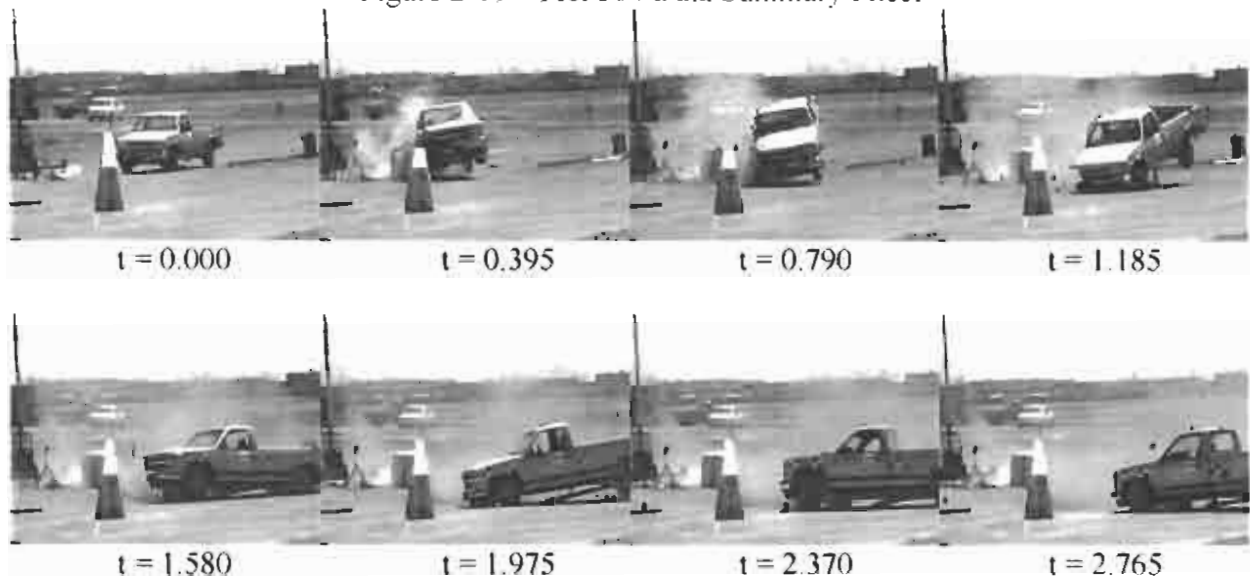
Figure 2-11 - Test 564 Data Summary Sheet

Damage to the barrier was limited to barrier deflection, two of the connection pins being pulled out of the pavement, and some minor concrete spalling. The maximum, permanent barrier deflection was 725 mm at the joint between segments 8 and 9 (see Figure 2-8). The barrier deflections led to the pins at joints 8-9 and 9-10 being pulled out of the pavement. Concrete spalling was limited to the leading edges of segments 8 and 10 where the vehicle snagged the barrier. All of the barrier segments were reusable

Barrier Damage: ..... Minor concrete spalling, moderate lateral displacement, and bent connecting pins.

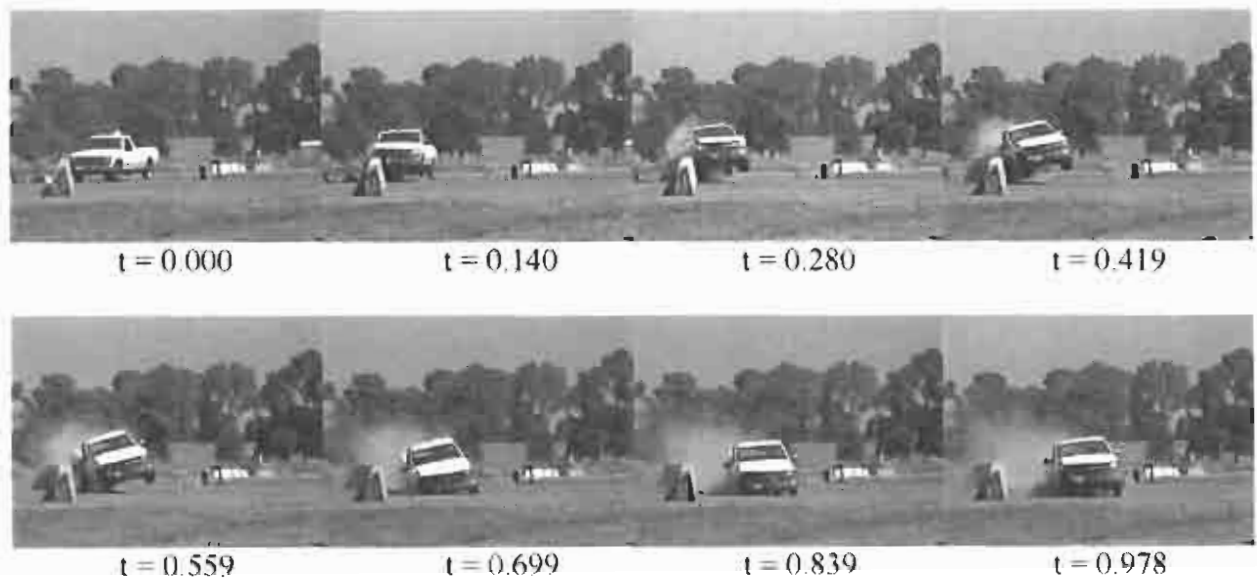
Figure 2-17 - Test 565 Data Summary Sheet

Damage to the barrier was limited to shifted segments, minor concrete spalling, bent connecting pins, and scuffing of the concrete face. Out of the 12 segments making up this barrier, only segments 1, 2, and 12 did not move. Segments 5, 6, 7, 8, and 9 had measurable lateral deflections. The spalling concrete occurred at joint 6-7 where the concrete is the thinnest. The connecting pins nearest the impact were bent, six of which had to be cut. All of the barrier segments were reusable.

Barrier Damage: ..... Minor concrete spalling,  
 ..... moderate lateral displacement, and bent connecting  
 pins.

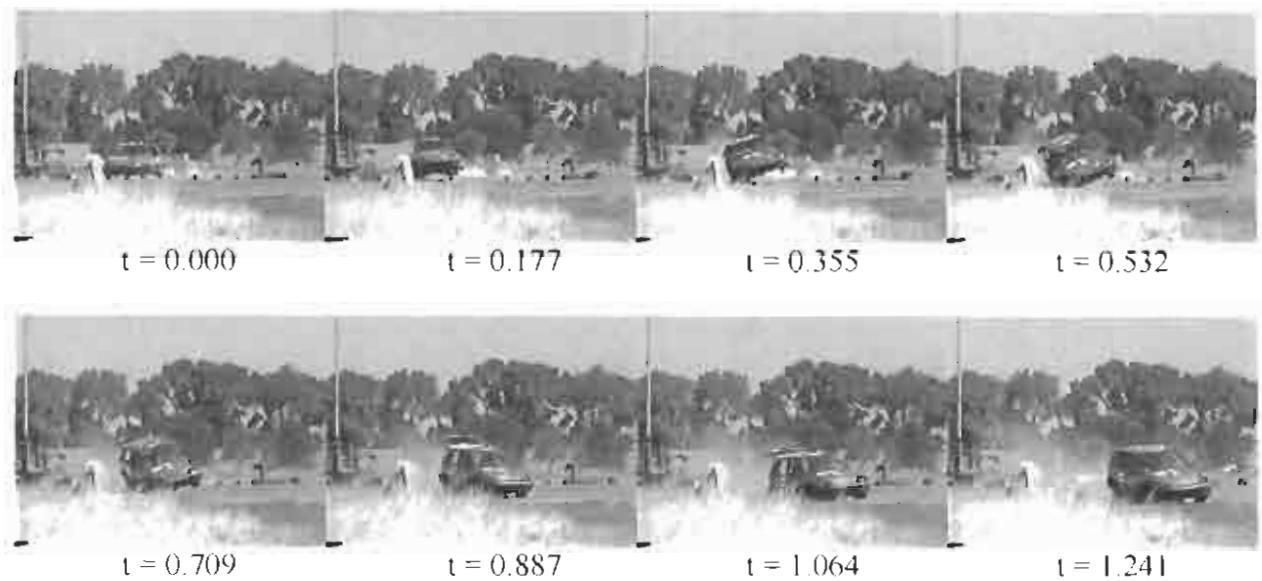
Figure 2-20 - Test 566 Data Summary Sheet

Most of the vehicle damage was limited to the front right corner of the vehicle. The corner panel was crushed and the hood had been buckled. The front right wheel was turned inward. The steering mechanism was damaged but the steering wheel could still turn the wheels. The tire was still inflated. The hubcap was missing from the front right wheel.

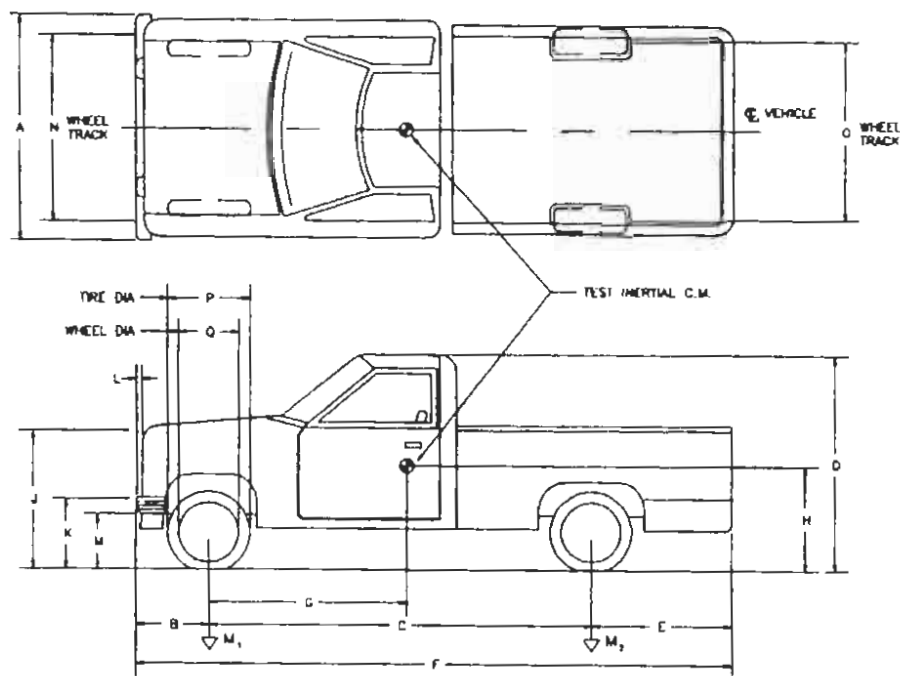
DESCRIBE ANY DAMAGE TO VEHICLE PRIOR TO TEST: Right door, lower rear corner has a shallow dent. The right side of the bed has a long shallow dent in front of the rear wheel.
